The pages to follow contain your *TOTAL HOME INSPECTION* report, which is based on observations made while conducting an inspection of any condominium in Fairfield County.

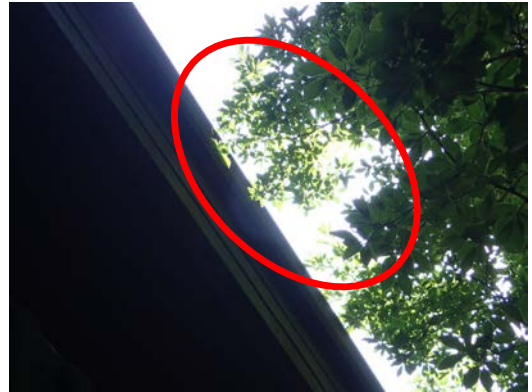
There are branches overhanging the roof and gutter system (see photo right for example area). By trimming or removing them, you will likely reduce roofing, gutter and siding maintenance and repair and you will also remove a potential bridge for animals.

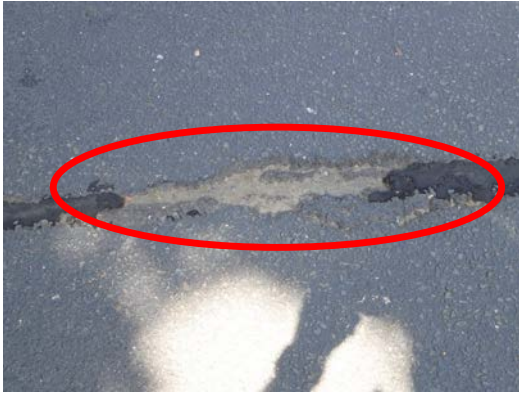
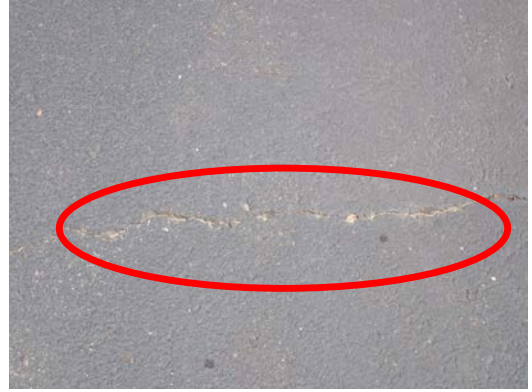
Portions of the "common" asphalt driveway surface and parking lot surface areas are starting to wear (see photos left and right for example areas). Filling the cracks with asphalt

cement and applying a coat of driveway sealer over the entire surfaces will help prolong the useful life of the common driveway and the parking lot.

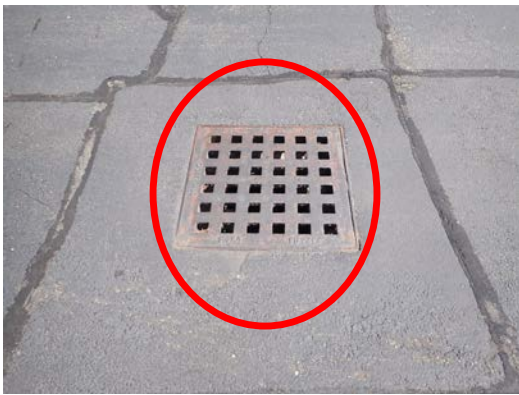
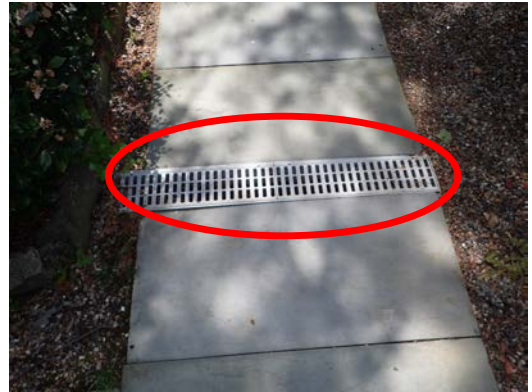
The "common" driveway and the "common parking lots" and the front "common" walkway are equipped with drains (see photos left and right for examples), which should be kept clean and free

flowing at all times to permit them to perform their designed function.

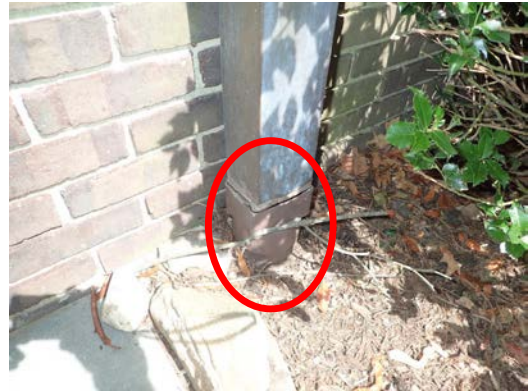
All rain leaders terminating into in-ground receptacles must remain free flowing at all times (see photo right for example of in-ground receptacle). Underground systems are vulnerable to clogging and should be checked annually.

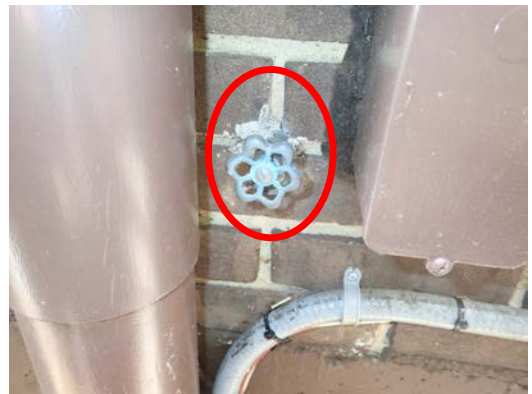
Water was supplied to the front and rear exterior hose bibcocks (faucets - see photo right for example of hose bibcock) at the time of this inspection. We recommend that the water supply to all exterior water sources and freeze vulnerable water sources are turned off in the autumn and that all hoses are disconnected from the faucets, to help prevent damage caused by pipes that may freeze. Inquire with the seller as to the locations of the inside shut off valves for these hose bibs.

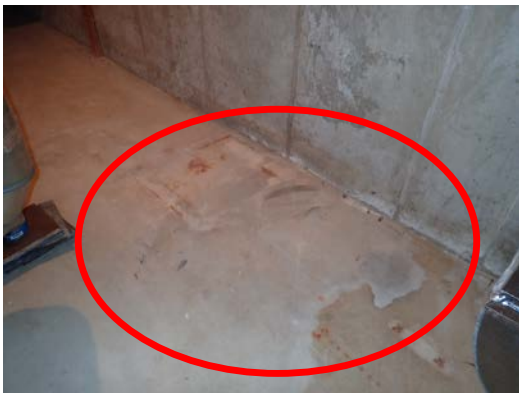
Watermarks were evident in the basement area (see photo left for example area). This indicates water has entered this area in the past. The basement was dry at the time of the inspection. Be sure that all exterior grades pitch away from the foundation and extend the guttering system as far away from the foundation as practical (see **LANDSCAPING** and **BUILDING EXTERIOR** sections of this report). It must be noted that any area below grade is susceptible to water seepage during certain weather conditions. If after performing the above recommendations, water seepage is still evident, consultation with a waterproofing specialist may be

necessary.

As representative measures toward controlling general dampness in the lowest level areas, we recommend that the cold water lines be insulated and that you consider installing at least one fan to enhance airflow and at least one dehumidifier to actively extract moisture from the areas.

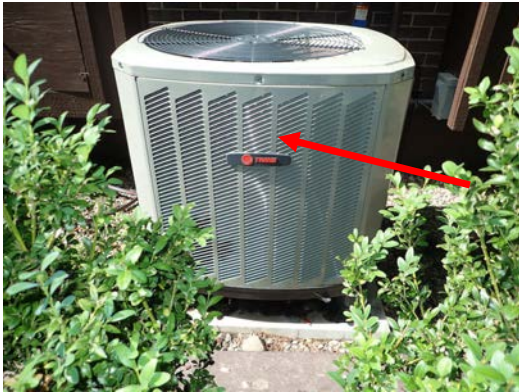
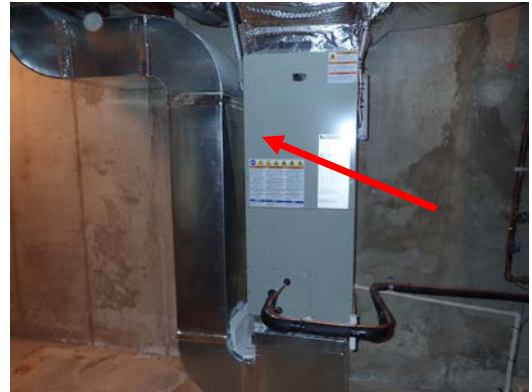
The heating and air conditioning in this dwelling are produced by a 3-ton Trane brand, electric heat pump (serial # 141232X7BF / model #

4TWP3036C1000AA - see photo above left). The system's evaporator unit/air handler is located in the basement utility room (see photo above right). The system was activated and found to be in acceptable working condition. This unit should undergo a regular service regimen. The regimen would include but not be limited to: checking the level of the compressor, checking the levels of and topping off the refrigerant, lubricating and cleaning the fan unit, vacuuming the evaporator coil in the heat pump unit, checking and periodically replacing the electric heating elements and verifying the operation of all safety functions. For maximum efficiency, service the equipment annually.

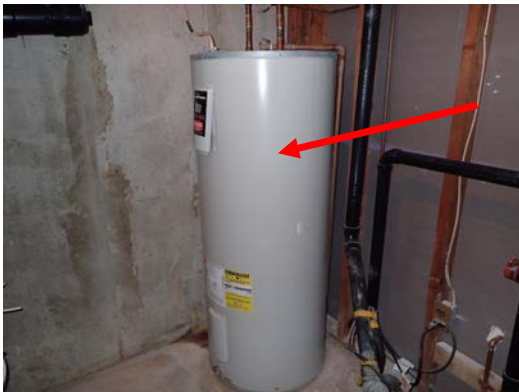
The water is heated by an independent, 80-gallon, electric, Bradford White brand, water heater (serial # AD4579698/ model #M280R6DS2 - see photo left) with a recovery rate of approximately 92 gallons per hour. The hot water supply system was evaluated and found to provide adequate amounts of hot water to all fixtures tested, at the time of this inspection.

According to our inspector's thermometer, the undiluted hot water temperature was approximately 111.5 degrees Fahrenheit. It is recommended that the undiluted hot water temperature remain between 120 degrees Fahrenheit and 125 degrees Fahrenheit to prevent scalding and for your comfort. Make the appropriate adjustments for your comfort purposes.

The water heater appears to be approximately 12 years old. Water heaters that service municipal water supplies and that are properly maintained have an average useful life expectancy of 10-15 years. These units deteriorate from the inside out. We have no way of determining the interior condition of the water heater. Your plans should include budgeting to replace the water heater before/when it fails.

We recommend installing a pan and a drain under the water heater to prevent damage caused by a system failure or the discharge from the temperature/pressure relief safety device.

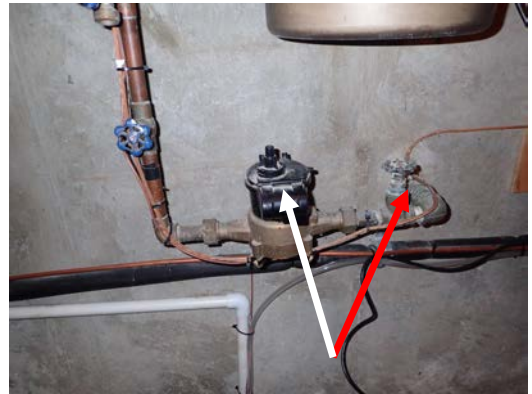
The main water supply piping is copper. The main shut-off valve is located in the basement utility room (see photo right – red arrow).

A "remote" meter reader has been installed on the water meter in the basement utility room (see photo right - white arrow), which should mean that the water meter should be able to be read remotely from the exterior of the condominium.

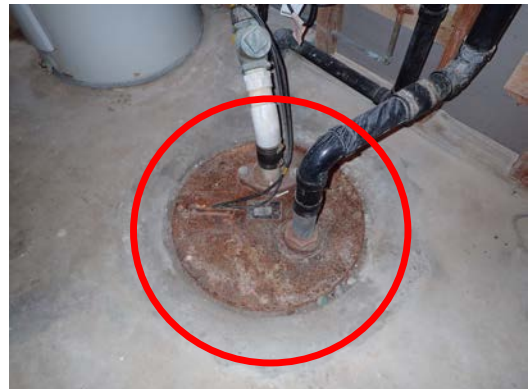
This condominium has been fitted with a sewage ejector pump system (see photo right of ejector pump pit cover). The pump appeared to be operating properly. Do not use any plumbing fixtures tied into this pump system during a power outage unless it is equipped with a battery backup system.

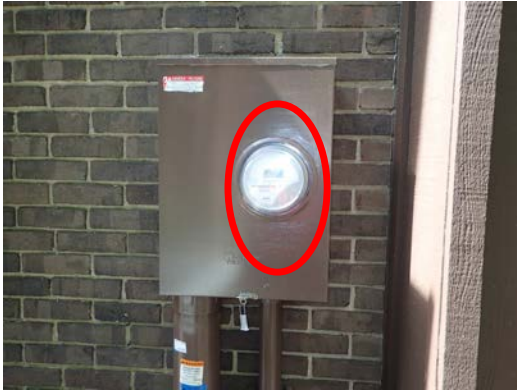
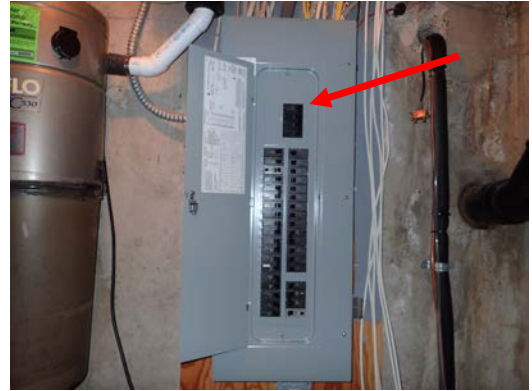
The 200-ampere, 120/240-volt electrical system enters the building via underground cables. The electric meter is located on the exterior of the building (see

photo left). The main service disconnect switch and primary panel board (load center) are located in the utility room (see photo right). The panel has been fed with aluminum feeders. Where visible the distribution conductors (wires) are copper, non-metallic sheathed cable (NM/Romex) type conductors (wires). They were in generally acceptable condition. All circuit breakers in the electrical panel should be properly labeled for your safety and for your convenience. The electrical breaker switches in the panel should be tested on an annual basis. The two existing "Arc Fault Circuit Interrupter" (AFCI) safety breakers in the main panel should be tested monthly. The system has been grounded to the incoming water pipe.

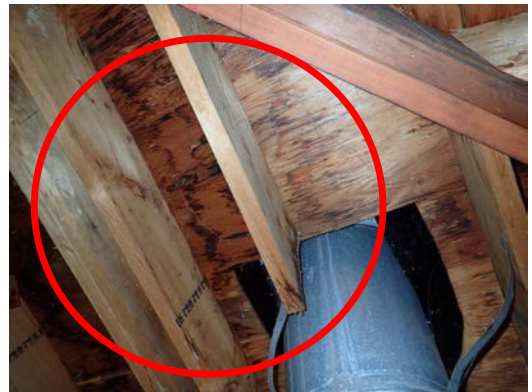
There was evidence of past water infiltration in the attic space (see photo right for example area). The water stains were dry at the time of this inspection. Inquiring with the seller may give you insight as to the time, nature and cause of the staining, as well as any corrective measures that were under taken.

It is virtually impossible for anyone to detect a roof leak, except as it is occurring or by specific water tests, which are beyond the scope of the standard home inspection we have performed for you. Even water stains on ceilings or on the framing within the attic will not necessarily confirm an active leaking. Naturally, the sellers or the occupants of the residence will generally have the most intimate knowledge of the roof and of its history therefore we recommend that you ask the sellers about the history of any and all leaks. We also recommend that you include comprehensive roof coverage in your home owner's insurance policy, or that you obtain a roof certification from a qualified, licensed roofing contractor.

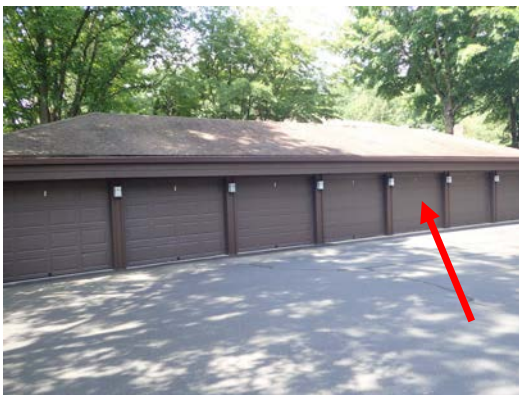
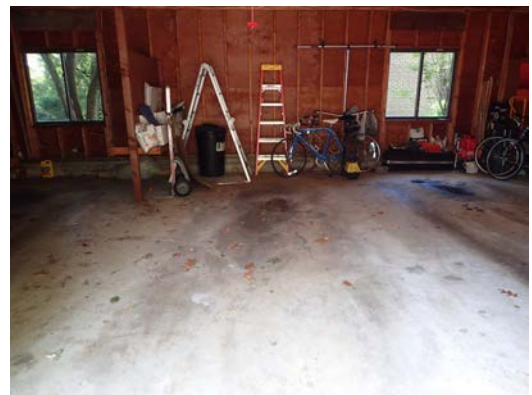
The detached, one-car garage (in a seven car "shared" structure – see photo left) has a concrete floor. The walls are wood and concrete blocks. The ceiling is

wood (see photo above right for view of the garage at the time of this inspection). All were found to be in generally acceptable condition, with the observations to follow to be taken into account and corrections made as required.

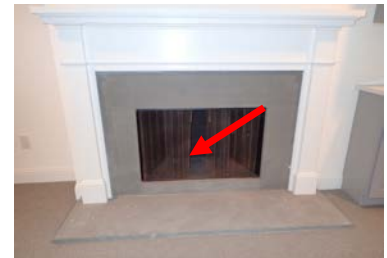
Family Room: The fireplace is an inserted, pre-fabricated, metal and ceramic fireplace structure (see photo right). We cannot determine the conditions behind such an insert, therefore no evaluation of the metal insert, the conditions behind the insert or the insert's components are contained in this report.

Due to the fireplace metal flue's configuration, our inspector was unable to evaluate its entire length. We recommend that you confirm the flue's condition, clearance and safety prior to using the fireplace.
