The pages to follow contain your *TOTAL HOME INSPECTION* report, which is based on observations made while conducting an inspection of any condominium in Fairfield County.

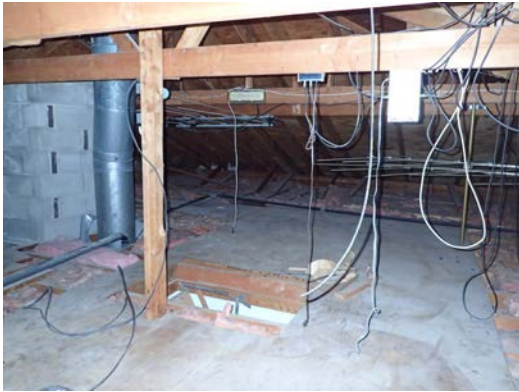
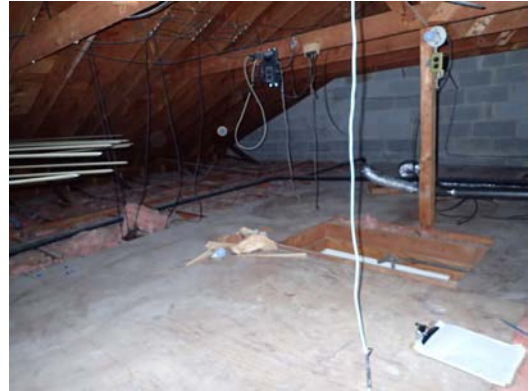
The attic was accessed by a pull-down staircase in the front left bedroom closet bedroom and it was inspected from within (see photos left and right for views of the attic at the

time of this inspection).

The accessibility, insulation, lighting and flooring were in generally acceptable condition. Consider the addition of more floored areas in the attic space to make the area even more suitable for storing your belongings.
